**Loading, Degradation and Repair of
F-111 Bonded Honeycomb Sandwich
Panels - Preliminary Study**

S. Whitehead, M. McDonald and
R.A. Bartholomeusz

DSTO-TR-1041

**Airframes and Engines Division
Aeronautical and Maritime Research Laboratory**

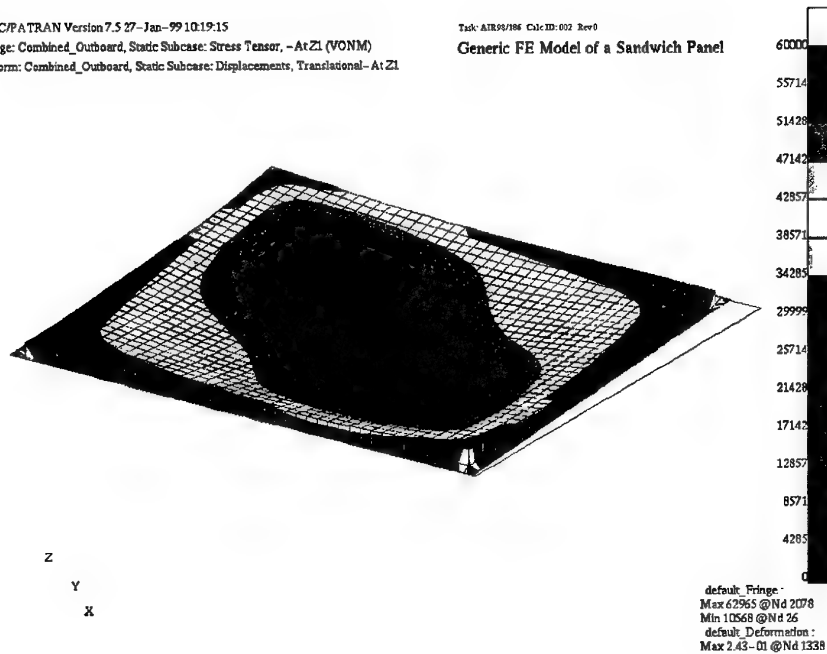
Figure 11: Contour plot of inner face stresses

The results of the FE analysis indicate that the stresses in the centre of the panel for all load cases, individual and combined, agree very well with the OEM face analysis calculations. A stress contour plot of the panel under combined ultimate loads is shown in Figure 11.

A comparison of centre panel stresses from each individual load case indicated that the face stresses were dominated by the shear, which contributed about 70% to the total stress field, followed by the aerodynamic pressure, about 20%, and the axial load, about 10%. Note that the stress or load distribution here is typical of a fuselage panel and may be different for aerodynamic surfaces such as rudders, ailerons or flaps where aerodynamic pressure may play a larger role. Work has not been undertaken in this study to examine the load and stress distribution of such components.

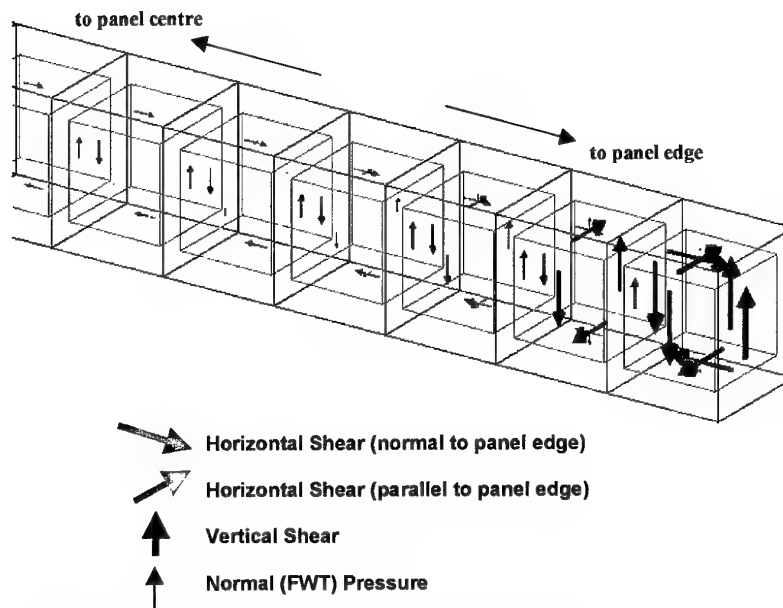
Figure 13: Internal loads in honeycomb core near the panel edge

Closer examination of the internal load distribution in the core can be seen in Figure 13. This figure also shows how the shear stresses dominate the total core stress field.

Based on the findings of the simplified FE model, the application of the ultimate static load to the panel is sufficient to generate core shear stresses of around 250 psi. At this time no conclusions can be drawn regarding the ability of the panels to withstand the ultimate load in the degraded or damaged condition due to the lack of a knock down factor or allowable for panel degradation in sandwich-panels. Work is required to develop these knockdown factors.

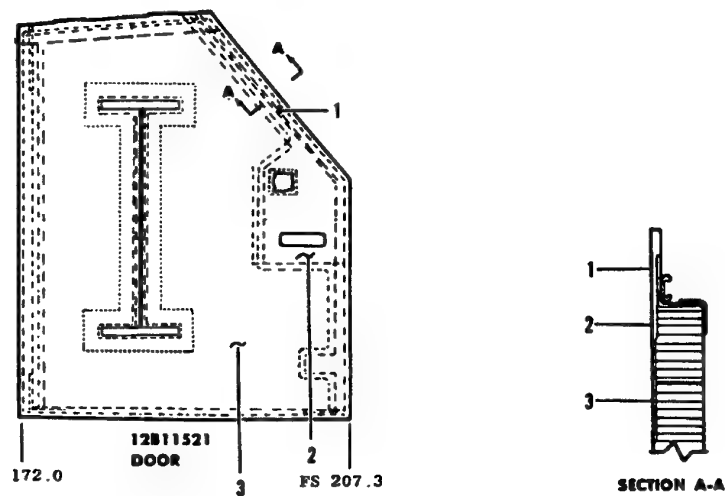
Figure 18. Panel 1102 structural detail. [2]

Detail of the panel's front view and cross-section is given in Figure 18. The construction details are given in Appendix A. There is an antenna attachment in the centre of the panel.
